# Attachments to the technical description

Maintenance Embassy of Croatia

Client: Embassy of Croatia

Reference:BJ1462-RHD-XX-XX-RP-X-0002Status:Draft/01

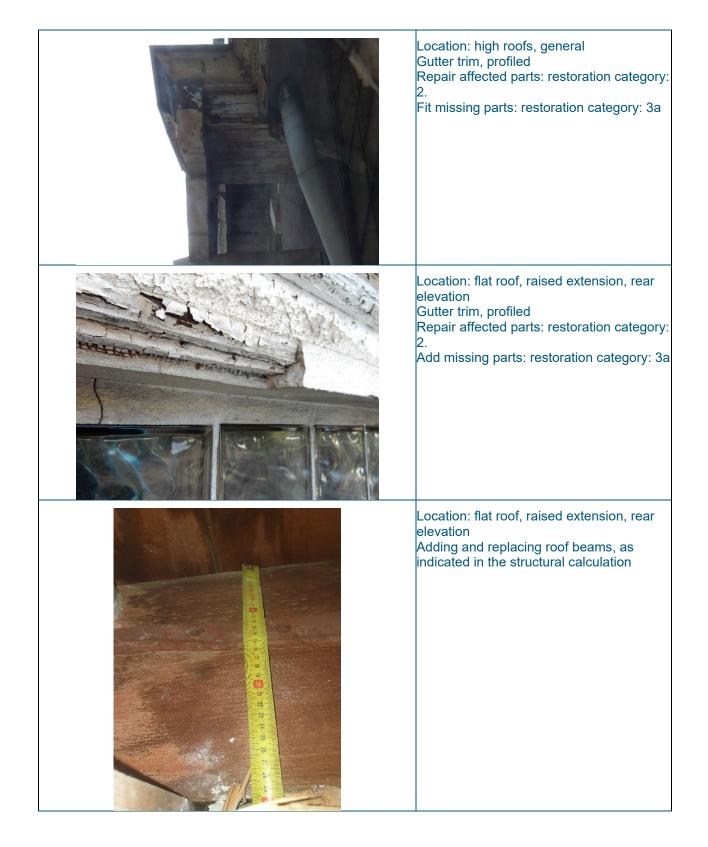
Location: flat roof Repair affected roof beams and roof boarding Restoration category (URL 3001): 2
Location: pitched roof Repair affected parts ridge, rafters and (horizontal) roof boarding Restoration category (URL 3001): 2
Location: high roofs, general roof cantilevers with consoles, Repair affected parts: restoration category: 2. Fit missing parts: restoration category: 3a
